***2017 ASPECT Preliminary Report
Arkema Plant Response
Crosby, TX***

***August 31, 2017
0600 hrs to 1900 hrs***

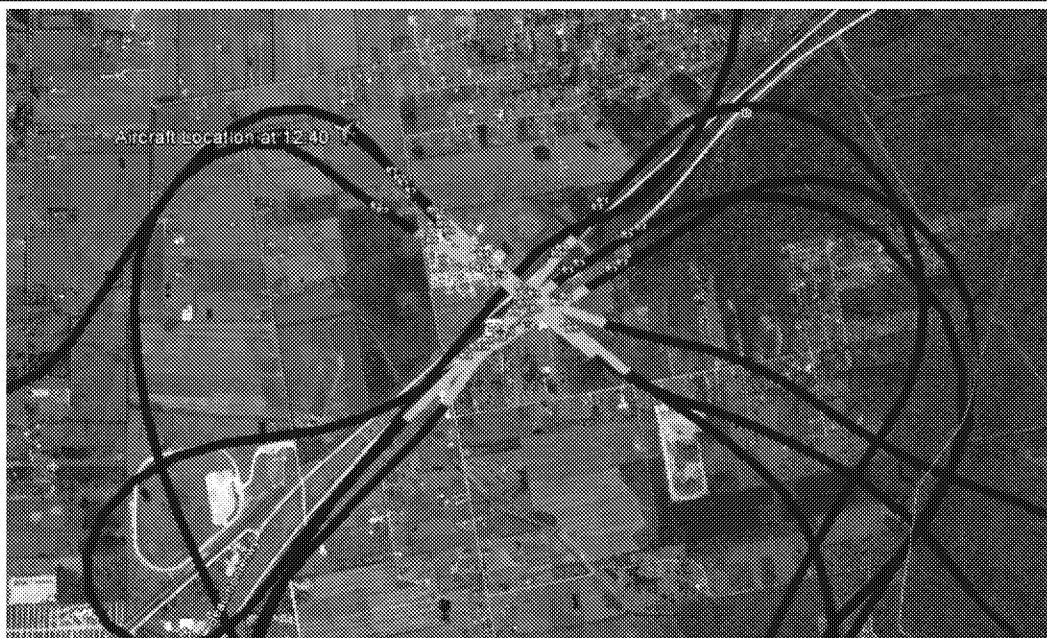
Figure 7: Flight path over the facility at 0731 hrs CST (1231 hrs UTC) showing several passes where aerial imagery and IR sensors were active.

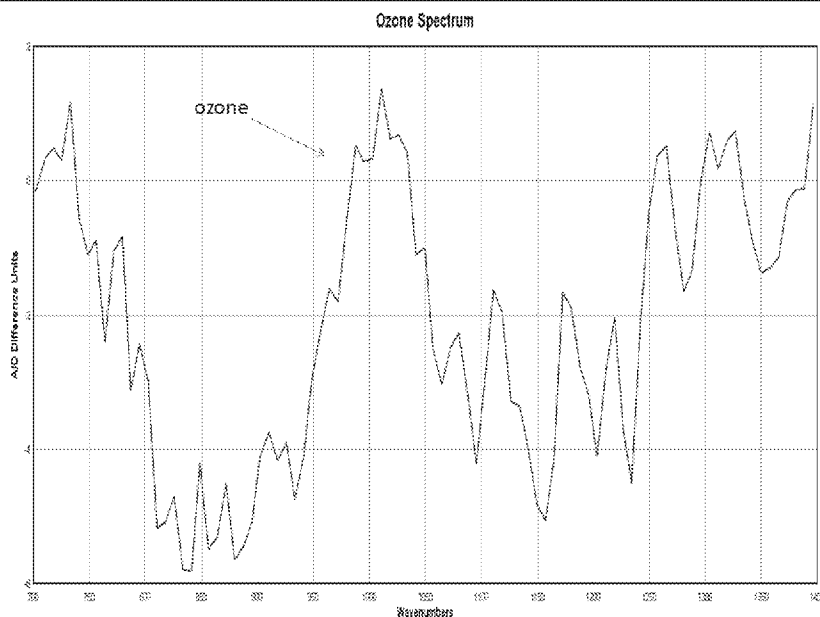
The ASPECT technical reach back team manually inspected and analyzed 21,000 FTIR spectral measurements from the morning sortie. No significant deviations or anomalies were associated with the explosion and subsequent fire, however ozone was detected which was likely created during the fire.

Figure 8: Passive (remotely detected at 2,800 ft AGL) FTIR spectra showing ozone, a commonly occurring air pollutant, but this measurement suggests that ozone is being generated by the fire (e.g., the spectral image shows that the ozone is hotter than the background). This also confirms that the instrument was operating properly.

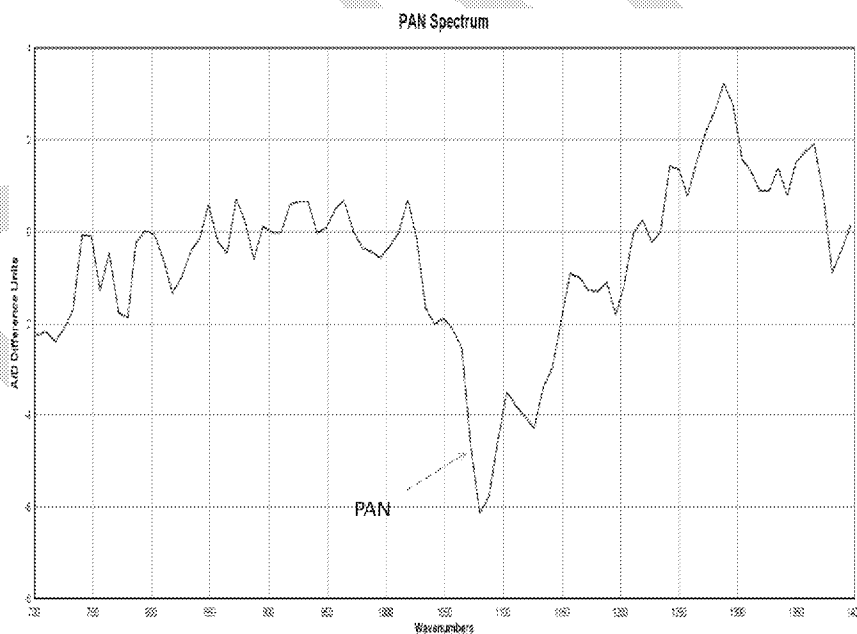
Figure 9: Passive (remotely detected at 2,800 ft AGL) FTIR spectra showing PAN (Peroxyacetyl nitrate), a commonly occurring air pollutant. This confirms that the instrument was operating properly.
